Innovative Solutions for Infection Control

Service Bus Assessment for Viral and Pathogenic Transport Between Users

Prepared August 2020

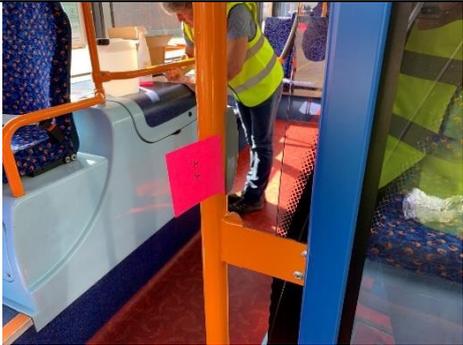
Sample Point	Picture
1 – Hand Rail on Entry

There was minimal bacteria recovered from Bus 1. There was low bacteria and light mould load from sample point 1 (entrance hand rail) and sample point 6 (seat back handle). There were slightly higher levels of bacteria recovered from sample point 3 (hand rail) and sample point 4 (seat back) with light and medium mould load respectively.

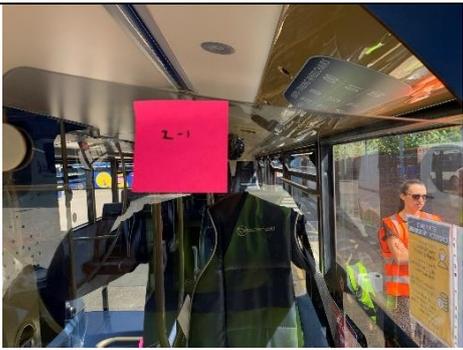
Sample Point	Picture
<p>1 – Glass Divider</p>

There was considerably more bacteria recovered from bus 2. There were medium levels of bacteria at sample point 1 (glass divider), sample point 2 (stairs grab rail) and sample point 4 (grab rail) with medium, light and light mould respectively. There were medium levels of yeast load recovered from sample point 4 (grab rail). Sample point 3 (carpeted wall) was significantly more contaminated with 100 CFU/cm² of bacteria load.
